Nossel Damage Analysis on Caterpillar Engine 3304 Wheel Loader 950 Unit

Faisyal*¹, Muh. Khalik², Muh. Taufik³, Baso Cante⁴, Mustafa⁵

^{1,2,3,4}Heavy Equipment Engineering Study Program, Department of Mechanical Engineering, Samarinda State Polytechnic

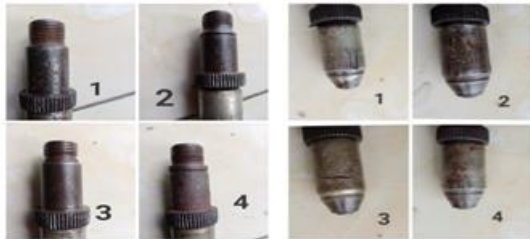
B. Nozzle Seat

At the top of the nozzle seat, there is visible corrosion caused by high temperatures, where the hot metal surface is open to air and oxidation occurs. Meanwhile, at the bottom, there is contamination due to careless dismantling or without proper procedures. The damage above does not in any way affect the working of the nozzle in the fogging process in the combustion system.

The conclusion from the visual analysis in the Nozzle section is that the nozzle on the 3304 wheel loader 950 Caterpillar engine can no longer be used due to a lot of fatal material damage.

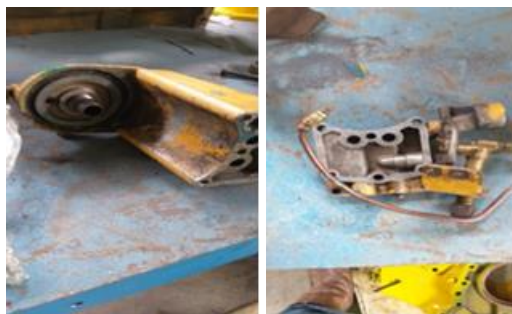
In the Bypass Valve section, no damage problems occurred and this component can be used again without problems

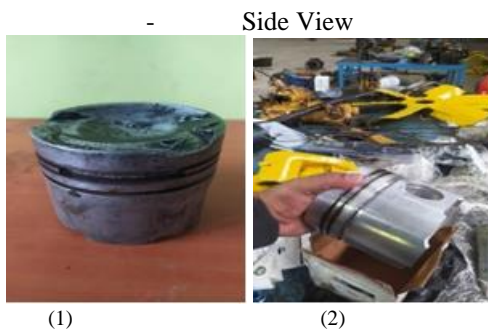
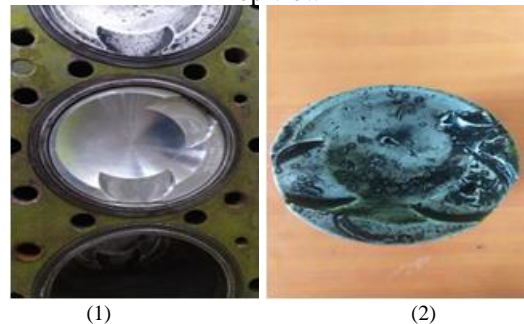
Piston number two at the top appears to be experiencing Cavitation Erosion, this is caused when the fuel fogging process forms air bubbles in areas of low pressure, and abnormal system conditions can trigger the appearance of additional water vapor bubbles. When these bubbles enter a high-pressure area, they explode, producing liquid pressure at very high speeds. Cracks (cracks) are very small and will increase until metal fragments occur, producing small holes.

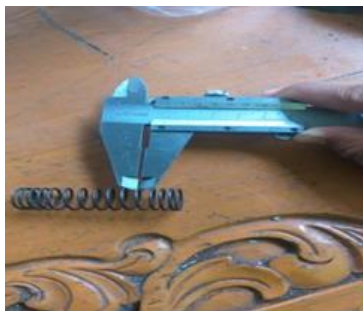
1. Diameter of Wire

Personal measurement results: = 1.5 mm
Spring specifications according to SIS: = 1.3 mm (0.5 in)

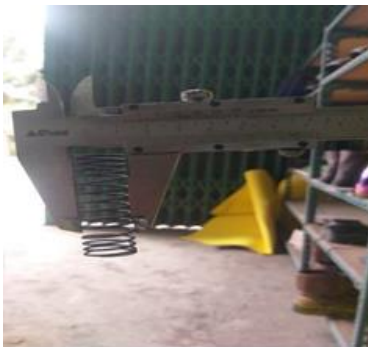
2. Outside Diameter

Personal measurement results: = 17.0 mm
Spring specifications according to SIS: = 17.8 mm (70 in)

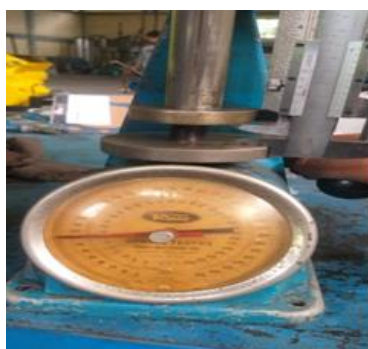
3. Length under test force

Personal measurement results: = 19.6 mm
Spring specifications according to SIS: = 26.4 mm

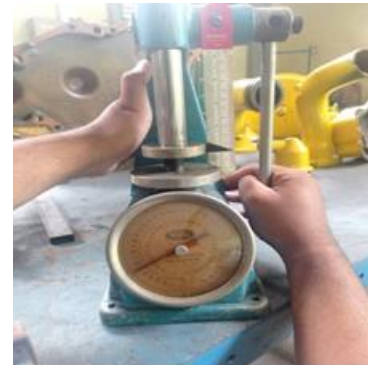
4. Length after test

Personal measurement results: = 45.7 mm
Spring specifications according to SIS: = 47.8 mm
