Assessment of the Structure of the Bappeda Building in Kutai Kartanegara Regency

Abstract— Since 2019, The Bappeda Building has suffered severe damage, including some cracked walls and cracked tile floors. The damage to this building is thought to be triggered by several factors, such as unstable soil structure and vehicle access that passes beside the Bappeda Building, causing vibrations to the building. The evaluation of the workshop building begins with collecting data in the form of as built drawings, results of inspections for damage to buildings, results of inspections of non-destructive tests and results of soil tests. Furthermore, structural analysis was carried out using the SAP 2000 program to determine the strength of the building and plan the required reinforcement. The results of the analysis show that the structure in the north of the Bappeda Kukar building is unable to withstand the load and the foundation settlement happened, so it is necessary to strengthen the foundation. Structural reinforcement in the form of the addition of 2 drill piles with a diameter of 60 cm and a depth of 32 m, and on top of it is installed using WF 800 mm x 300 mm x 14 mm x 26 mm beams w

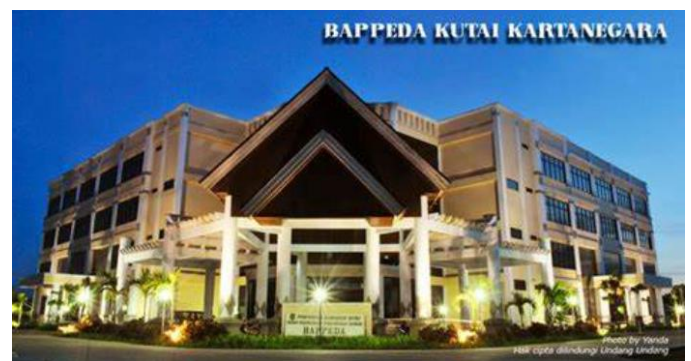
Fig. 2. The front view of the building

In 2019 this building began to experience damage in several parts, including part of the walls cracked, broken glass doors and windows, cracked tile floors and part of the ceiling collapsed. The damage to the building is estimated to have

been triggered by several factors, such as the unstable soil structure and vehicle access next to the Bappeda Building which has direct access to and from the Kukar Bridge, causing vibrations that affect the structure of the Tenggarong Bappeda Building.

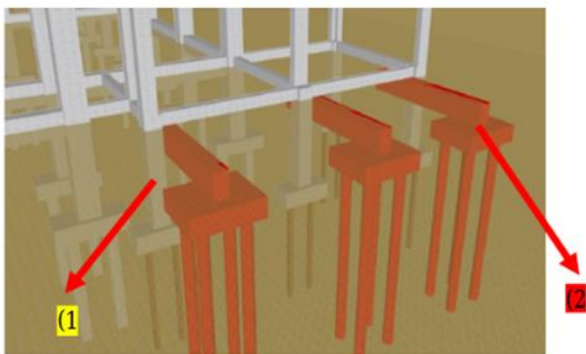
Fig. 4. Foundation repair sketch

To prevent further settlement, the foundation design is designed on the side of the foundation which has decreased as shown in Figure (4). From the calculation results, the foundation design is obtained as follows.

At point (yellow 1) the foundation has decreased because it cannot withstand the weight of the building. At point (red 2) a new foundation is made to withstand the load on the foundation (yellow 1) so that the foundation does not experience a settlement later.

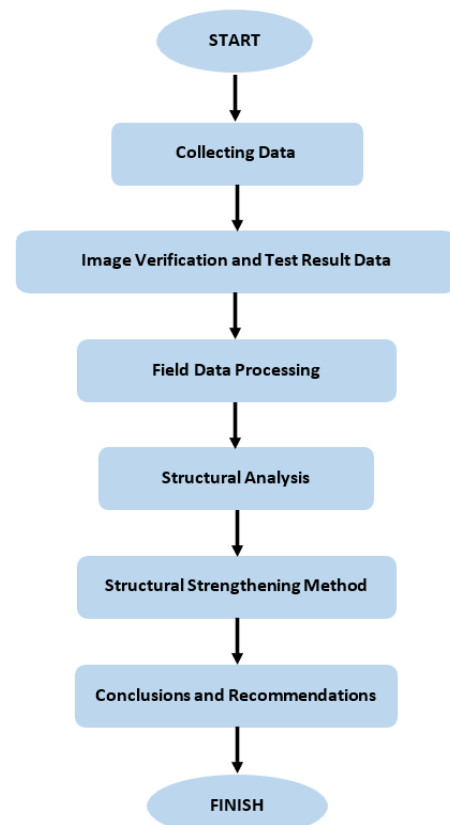
Fig. 5. Assessment flowchart

In general, the research method used is described in the following steps:

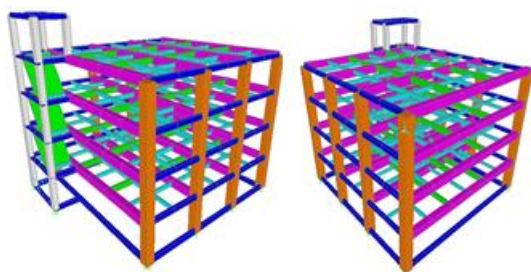
Fig. 6. Perspective view

- The structural analysis model is as shown in the following figure. 2D modeling with frame elements to model slabs, columns, and beams.

- 3D portal structure modeling using the SAP2000 version 14 program.
- The main elements are columns, beams, and slabs as frame elements.
- The dead load comes from its own weight and additional dead loads as well as other supporting elements which are attached to Portal Loading Calculation 1-1.
- The review was carried out on the attached portal (Portal 1-1).

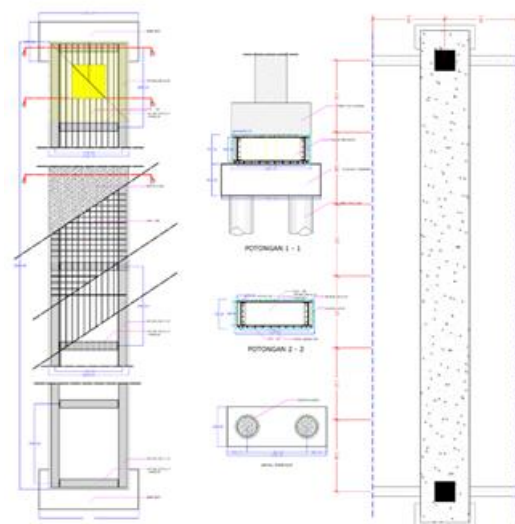
Fig. 8. Portal reinforcement illustration 1-1

From the results of the analysis and evaluation of the structure of the Bappeda Kutai Kartanegara Building, it was found that reinforcement would be given to the foundation on the north side/back of the building which was experiencing a decline. The reinforcement is in the form of adding 2 drilled piles to the right and left of the existing foundation. The drilled pile is planned to have a diameter of 60 cm with a depth of 32 m and on top of that a WF 800 x 300 x 14 x 26 beam wrapped in concrete which functions as a pedestal for the existing foundation is installed. Strengthening Portal 1-1 and Portal 2-2 with the following illustration:
