# Landslide Hazard Mapping in Mbankolo Yaounde Cameroon: Multi-Factor Analysis and Outlook

**Keywords**— Hazard, Landslide, Risk mapping, Multi-factor approach, GIS, Remote sensing, Mbankolo.

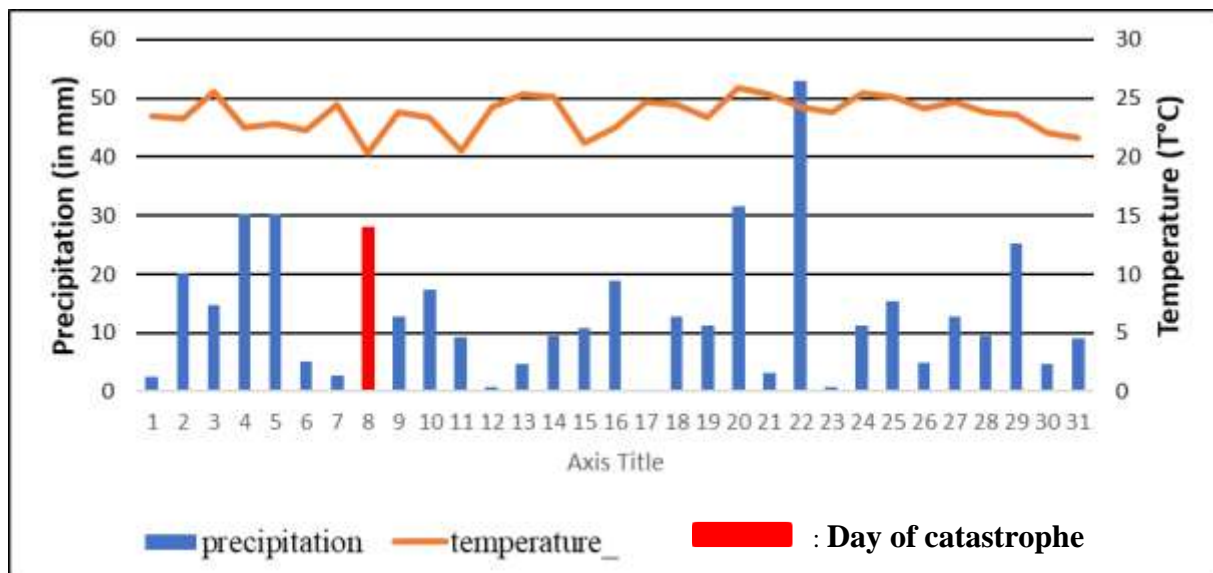
Figure 6: Umbrothermal diagram for October 2023

In the context of studies on natural hazards, and in this case landslides, the action of rainfall is a decisive factor. The intensity of heavy rainfall once on the ground saturates surfaces and subsurfaces through infiltration. Infiltration plays a major role in soil pore pressure. These pore pressures exert pressure on the soil wall, causing deformation and leading to site instability. In the case of the Mbankolo disaster, an estimated 28.13mm of precipitation was recorded, which represents a significant rate given that the rain fell in just a few hours. In addition, a monthly rainfall total of 423.47mm was recorded (figure 6). This heavy rainfall played a major role in setting up the Mbankolo disaster as the main catalyst.

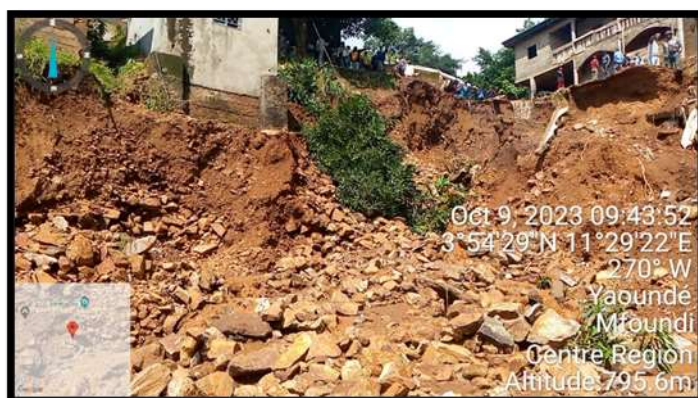
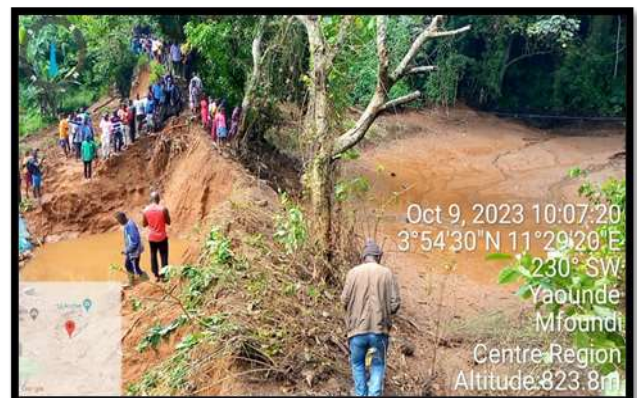
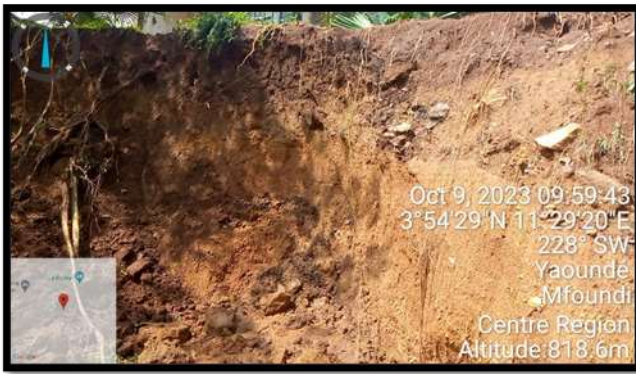
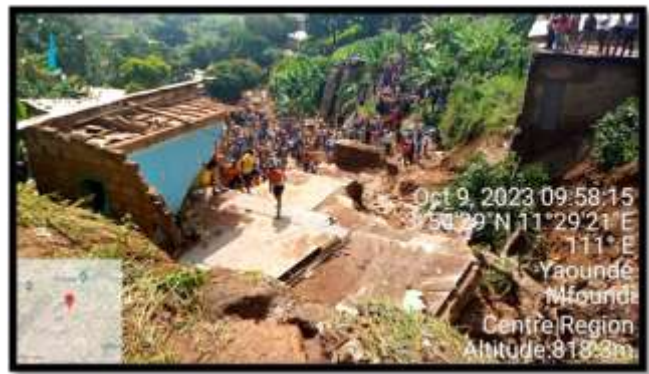
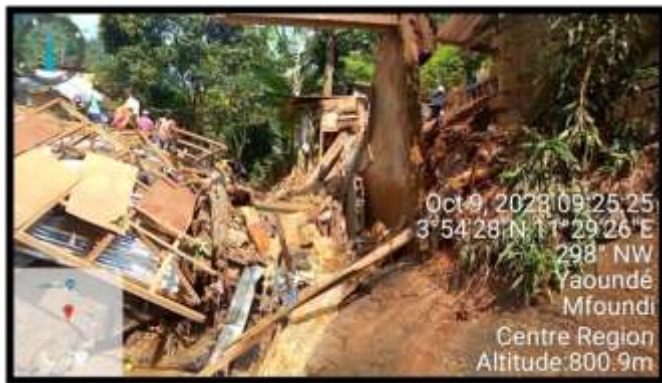
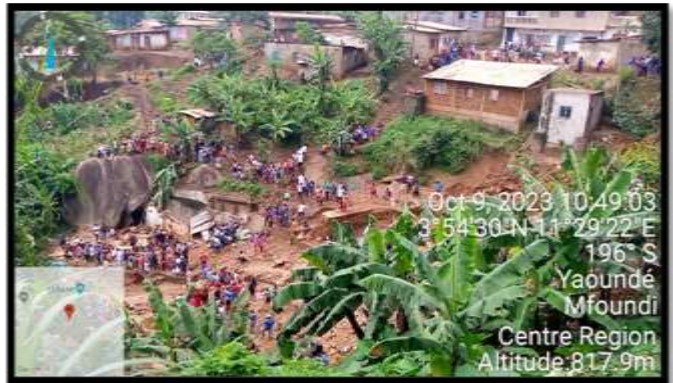
*Pictures of Landslide area*

The Mbankolo district in the Yaoundé 2 council is an under-structured neighborhood with a very uneven topography and steep slopes. On the evening of October 8, 2023, a landslide caused the death of around thirty people, as well as significant material damage. Observations in the field show that the movement was rotational at the trigger point and translational thereafter, given the slope gradient. This observation is supported by the presence of uprooted trees pointing downslope, with the fallen retaining wall facing

downslope. What's more, a mini pond that used to be full of water was emptied during heavy rainfall, putting pressure on the wall built on sandy clay soil, which eventually gave way.
