TexTILES: Crafting Sustainable Building Cement Tiles with Discarded Cotton Woven Textiles

Arwina Hasan Salcedo¹, Engr. Ilde Balanay Deloria²

¹Department of Sanitary Engineering, Western Mindanao State University, Zamboanga City, Philippines -7000

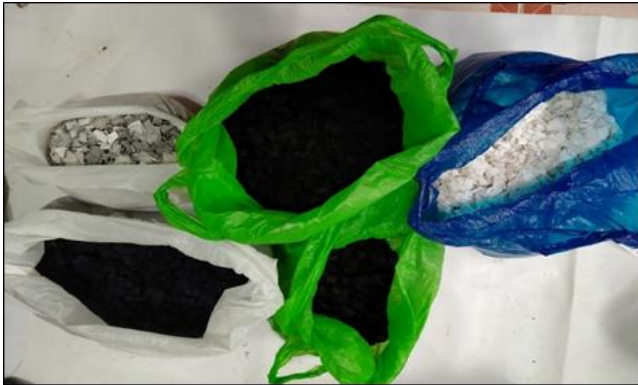
Figure 2. Preparation of Materials: Shredded Discarded Cotton Woven Textiles

The textiles were sorted and cut into small square pieces. These were mixed with cement, sand, and water in measured amounts. Three different mixtures were prepared by changing how much textile was added while keeping the amount of cement the same.

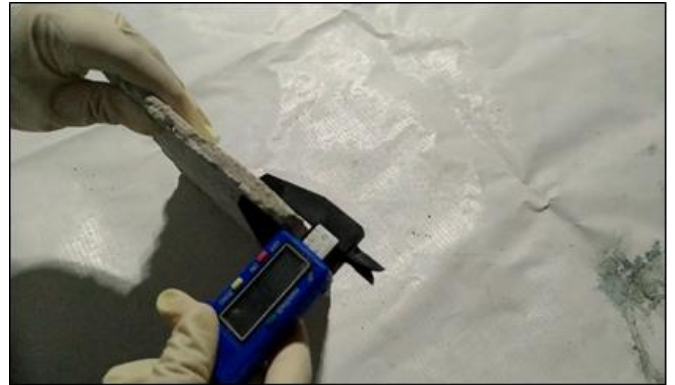
Figure 6. Physical Characteristics Determined through Non-destructive Testing Method

Ten (10) replicates per embodiment (E1, E2, E3, and Control) were randomly selected and inspected for structural defects (cracks, chips, surface inconsistencies) based on PNS 154:2005. Tiles were rated using a 1–5 scale to assess conformance to quality standards.

Length and width of each replicate were measured using a caliper. Four measurements per tile were averaged. Size variation (%) was computed as:

Flatness was assessed using a level bar per PNS 154:2005 guidelines.

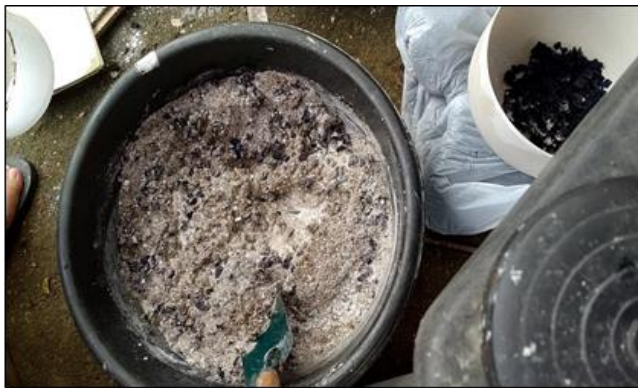
Figure 3. Mixing of the Raw Materials

The materials were mixed until smooth and evenly combined. The mixture was poured into the molds, tapped to remove air pockets, and leveled. Enough tiles were made to meet the testing needs for all groups.

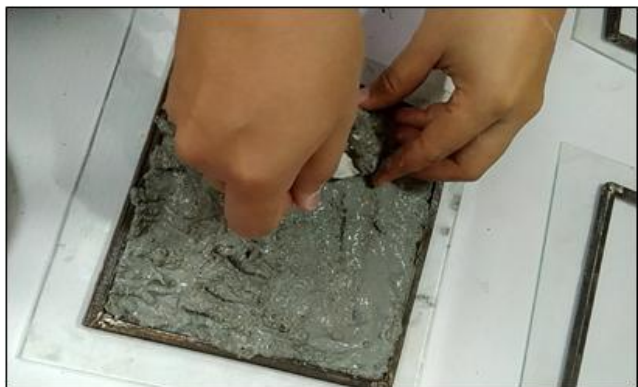
Figure 4. Casting/ Pouring of the “TexTILES”

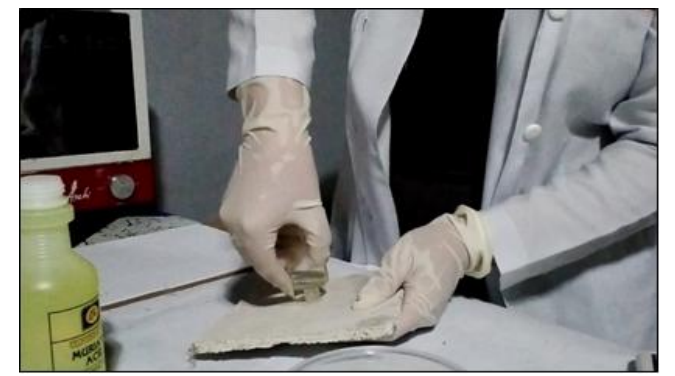
Figure 8. Physical Characteristics Determined through Destructive Testing Method- Chemical Resistance

Per ASTM C650-20, tiles were exposed to 10 mL chemical solutions for 24 hours, rinsed, dried, and visually classified as "affected" or "not affected."

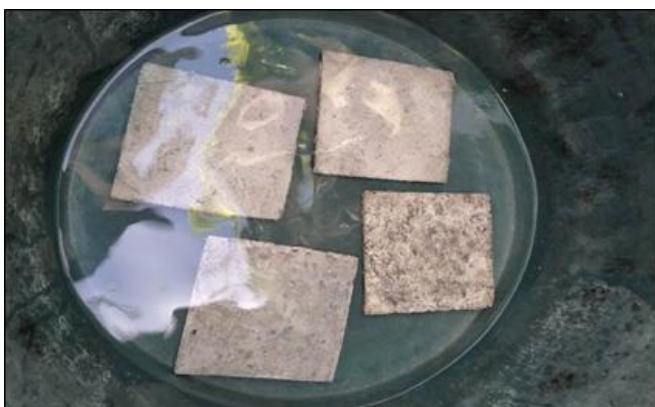
Figure 5. Curing of the “TexTILES”

After being shaped, the tiles were left to dry in the air for a short time. Then, they were placed in water for a longer period to harden and gain strength.

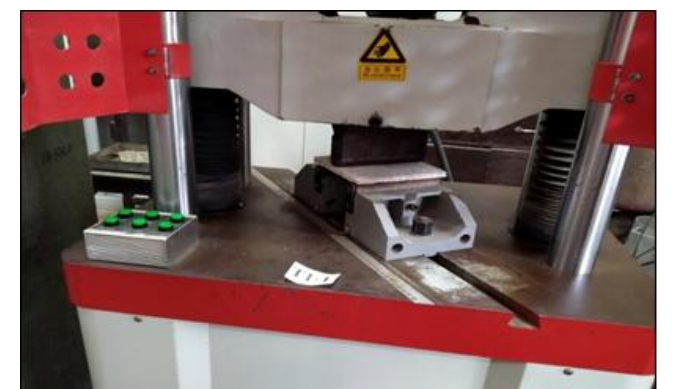
Figure 9. Physical Characteristics Determined through Destructive Testing Method- Modulus of Rupture

Based on PNS ISO 10545-4, 10 replicates per group underwent 3-point loading until failure. MOR was calculated as:

E3 complied with all destructive test requirements. It scored well in abrasion resistance, chemical resistance, water absorption, and stain resistance. Most notably, E3 demonstrated superior flexural strength, with a modulus of rupture of 7.55 MPa, exceeding the minimum standard of 6 MPa.
