Nossel Damage Analysis on Caterpillar Engine 3304 Wheel Loader 950 Unit

Faisyal*¹, Muh. Khalik², Muh. Taufik³, Baso Cante⁴, Mustafa⁵

^{1,2,3,4}Heavy Equipment Engineering Study Program, Department of Mechanical Engineering, Samarinda State Polytechnic

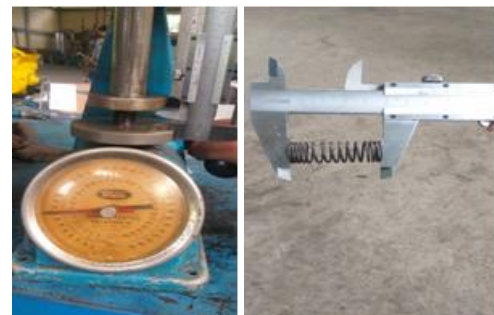
Length under test force	19,6 mm
Test force	-
Free length after test	45,7 mm
Outside diameter	17,0 mm
Diameter of wire	1,5 mm

The conclusions of this research are from the visualization measurement data, the following data is obtained: length under test force is 19.6 mm, free length after the test is 45.7 mm, the outside diameter is 17.0 mm, the diameter of wire is 1.5 mm. Meanwhile, data from spring specifications according to SIS are: length under test force is 26.4 mm, free length after the test is 47.8 mm, the outside diameter is 17.8 mm, the diameter of wire is 1.3 mm. From the data above, it still meets the spring specifications according to SIS
